MAINTENANCE ALERT!

When was the last time you inspected your system's Check Valve(s)?

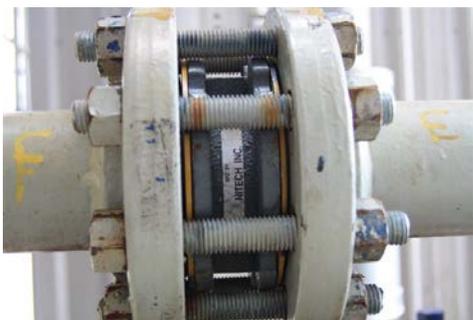
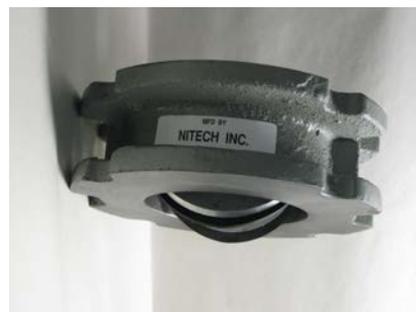
Potential air leakage location

You may not even realize that your vacuum pump system has more than one check valve. These, however, are critical components. If your process isolation valve fails to operate during a system shut down the check valve upstream of the vacuum pump prevents air leakage into the main condenser.

A faulty check valve in the bypass line of vacuum pump will result in reduced performance of your vacuum pump.

The internal sealing material(s) can wear resulting in loss of performance in the form of air leakage. Pump damage, which is not covered under warranty, could result from a worn or unmaintained check valve. We recommend your check valves be placed on a scheduled maintenance plan with the frequency adjusted according to wear findings. Inspection protocol frequency should not exceed two years.

- 1) Prior to any maintenance inspection, it is recommended that a spare Check Valve(s) and Gaskets be on hand to install in case a replacement is needed.
- 2) Contact Nitech Inc.'s Spare Parts Department for pricing and availability.
- 3) **CAUTION:** Vacuum system must be turned off for inspection.
- 4) Consult your assembly drawing for the location of the Check Valves. The Check valves are located in the vacuum pump bypass line that leads to the separator tank and in the process inlet line just upstream of the vacuum pump.
- 5) Loosen and remove bolting as needed in order to facilitate removal of check valve(s). **CAUTION:** Piping may require supporting during removal.
- 6) Remove Check Valves and inspect them. Verify that the sealing gasket inside is smooth and free of cracks. Verify that the sealing surface is free of corrosion or rust scale. Replace as necessary.
